Manhole Inspection Summary

Manhole # S04AA2024MH

Location Address: **3602 CLARINTH RD** Cross Street: **PARK HEIGHTS AVE**

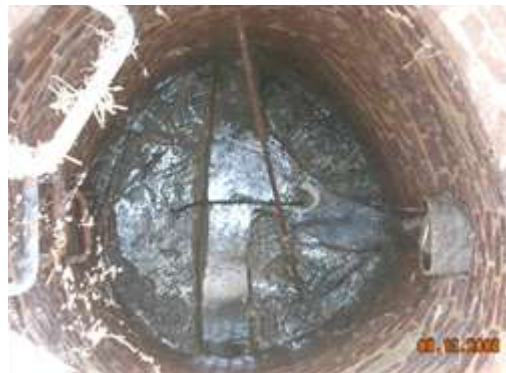
Top View

Corroded steps. Bench debris.

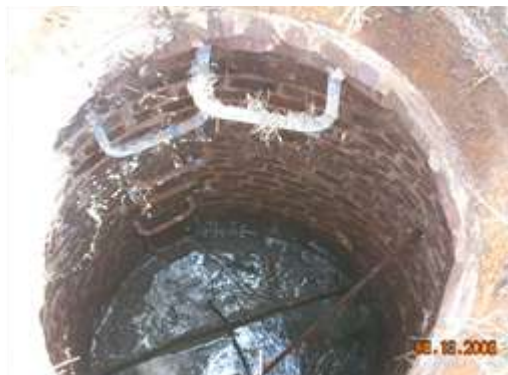
Defect

Frame leaks. Frame offset. Corbel deterioration and infiltration. Barrel infiltration.

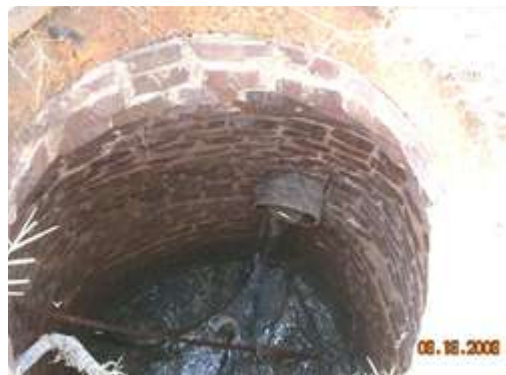
Defect

Frame leaks. Frame offset. Corbel deterioration and infiltration. Barrel infiltration - other side.

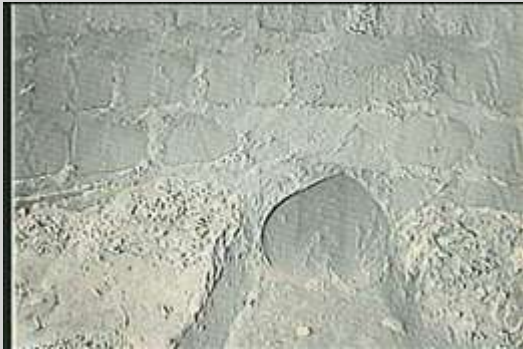
8 in. Circular Gravity Sewer Pipe Out @ 12 O'Clock

Infiltration: **Evidence** Pipe Seal Cond: **Broken**

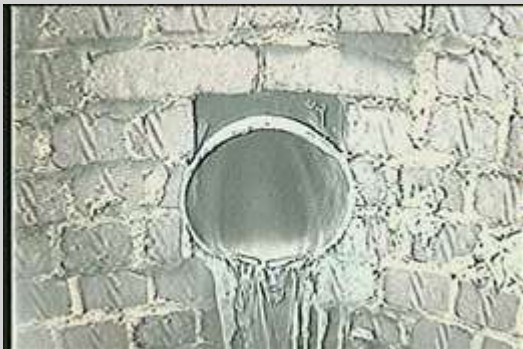
8 in. Circular Gravity Sewer Pipe In @ 3 O'Clock

Infiltration: **None** Pipe Seal Cond: **Broken**

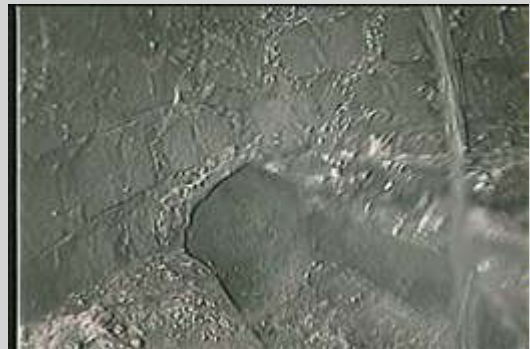
Drop In @ 3 O'Clock

Barrel deterioration and infiltration.

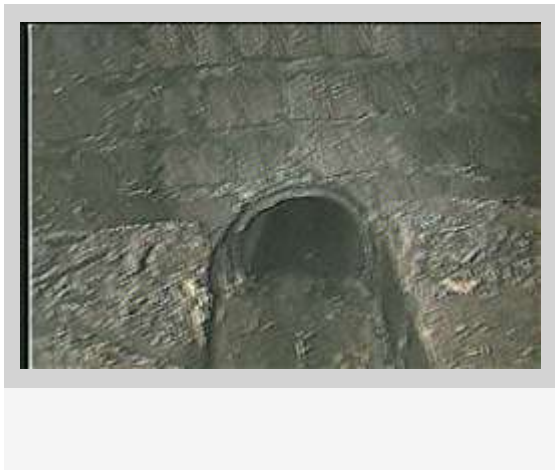
8 in. Circular Gravity Sewer
Pipe In @ 6 O'Clock

Infiltration: **Evidence** Pipe Seal Cond: **Broken**
